A Naval Safety Center Publication

JANUARY 1976 THE NAVAL AVIATION SAFETY REVIEW

CV Safety Organization

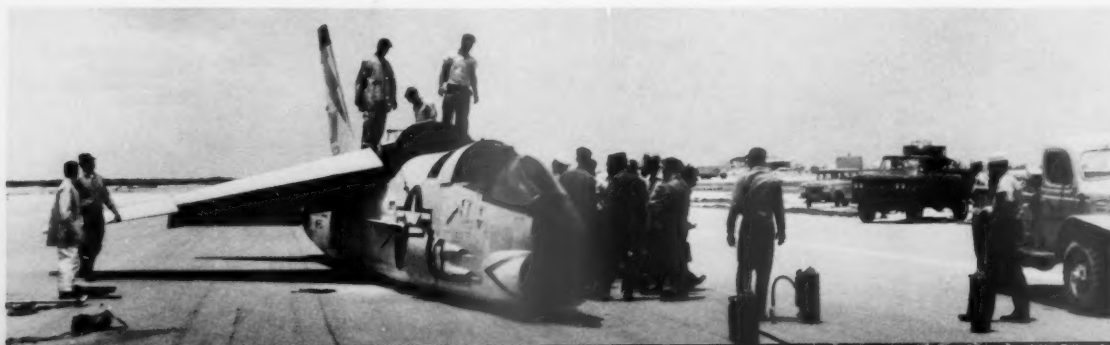
Unintentional Wheels-Up Landings in Fixed-Wing Aircraft
From FY-67 through Apr 1975

67	68	69	70	71	72	73	74	75	Total	Rate of Wheels-up Landings per 10,000 Landings (Disembarked)
A-1			2		1					3	.30
A-3	1	1		1	2	2		1		8	.14
A-4	4	4	2	1	1	1	2	2	3	20	.063
A-5			1							1	.07
A-6					1	1		1		3	.05
A-7			1					2	1	4	.03
C-1			1							1	.04
E-1				1						1	.06
E-2					1			1		2	.10
F-4		1			1					2	.01
F-8	2		1							3	.07
F-9	1		3	1						5	.03
F-10			1							1	.66
P-2		1				1				2	.06
P-3		1							1	2	.02
S-2	2	3	2	1	2	2	1			13	.05
T-2						1				1	.004
T-28	2	1	4				1	2		10	.03
T-33		1		1		1				3	.36
T-34	2		1				1	3		7	.02
U-3								1		1	2.2
U-11					1					1	.15
AV-8						2			1	3	.73
OV-10			4	1		1	1			7	.36
Totals	14	13	23	7	10	12	6	13	6	104

The accompanying chart shows the unintentional wheels-up landings of fixed-wing aircraft, by years, during the period FY-67 through April of FY-75. This includes six aircraft destroyed and 22 substantially damaged. All others received minor or limited damage. There were four major and four minor injuries during this period, which is regrettable, but considering the potential hazards, we can rejoice that there were no more injuries.

Only four out of 104 of the accidents occurred onboard ship. The reason for this is obvious; LSO, hook spotter, etc., observing on every pass. Shorebased, the T-2, T-34, and T-28 were among the best performers (one wheels-up for each 2,408,132; 407,555 and 340,280 landings, respectively). This indicates that instructor pilots, RDOs, and/or a high degree of standardization of operations (all found in the Training Command) are effective in preventing unintentional wheels-up landings. As can be seen from the rates, no firm conclusions can be drawn concerning the relative merits (or hazards) of single-place versus multi-place cockpit aircraft.
